**DESIGN AND INSTALLATION
OF WALLS & CEILINGS
IN TALL BUILDINGS**

DESIGN AND INSTALLATION OF WALLS & CEILINGS IN TALL BUILDINGS

INTRODUCTION

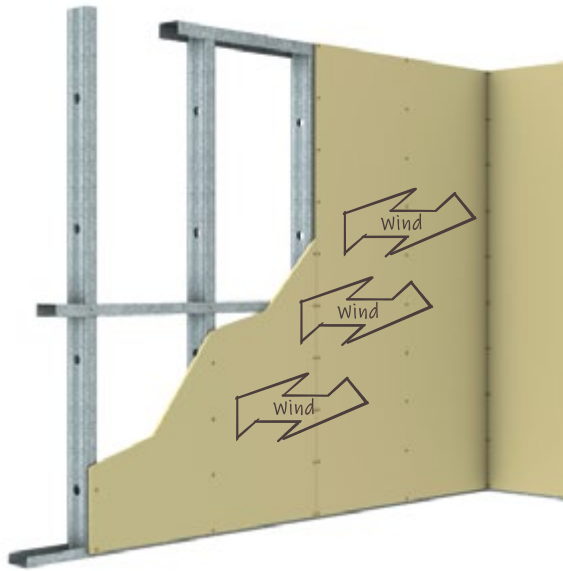
■ WIND LOAD ON WALLS

Internal pressures are determined in accordance with AS/NZS1170.2 Clause 5.3, using the basic external pressures for the building and are applicable for both walls and ceilings. The internal pressures cannot be ignored, and in some situations can be upwards of 1.0kPa.

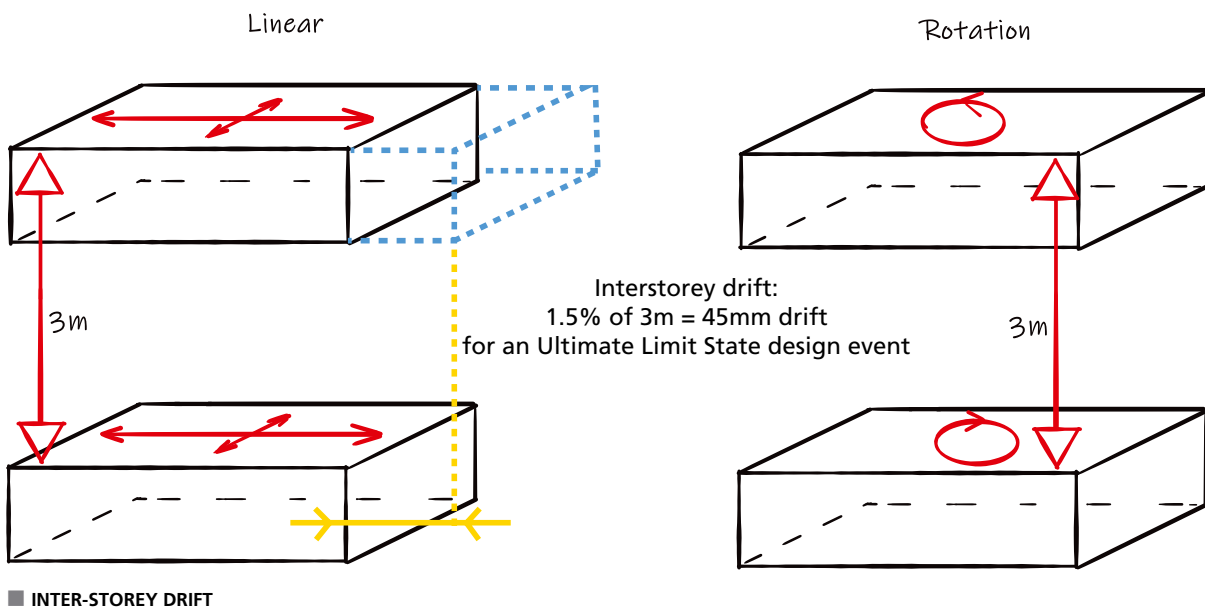
Inter-storey drift is the relative movement between two consecutive floors and can be in any plane horizontal to the floor. It is proportional to the distance between the floors and the overall building stiffness, but is limited to 1.5% of the floor height under AS1170.4 for Australia, at an Ultimate Limit State (ULS) design seismic event. That means for every 1m of storey height the floors are permitted to drift up to 15mm in any direction. The building will move with the force of the earthquake and can have one floor moving in the opposite direction from the one below. This movement can take the form of a wave up the building and can also result in rotational movement of the superstructure due to the torsional effects arising from the structural form of the building.

For concrete superstructures, AS3600 limits the inter-storey drift to $H/500$ under a Serviceability Limit State design event and this equates to 2mm per 1m of storey height. This is significantly lower than the ULS limit and is typically taken as the no significant damage limit for the Rondo wall and ceiling systems, unless specified otherwise.

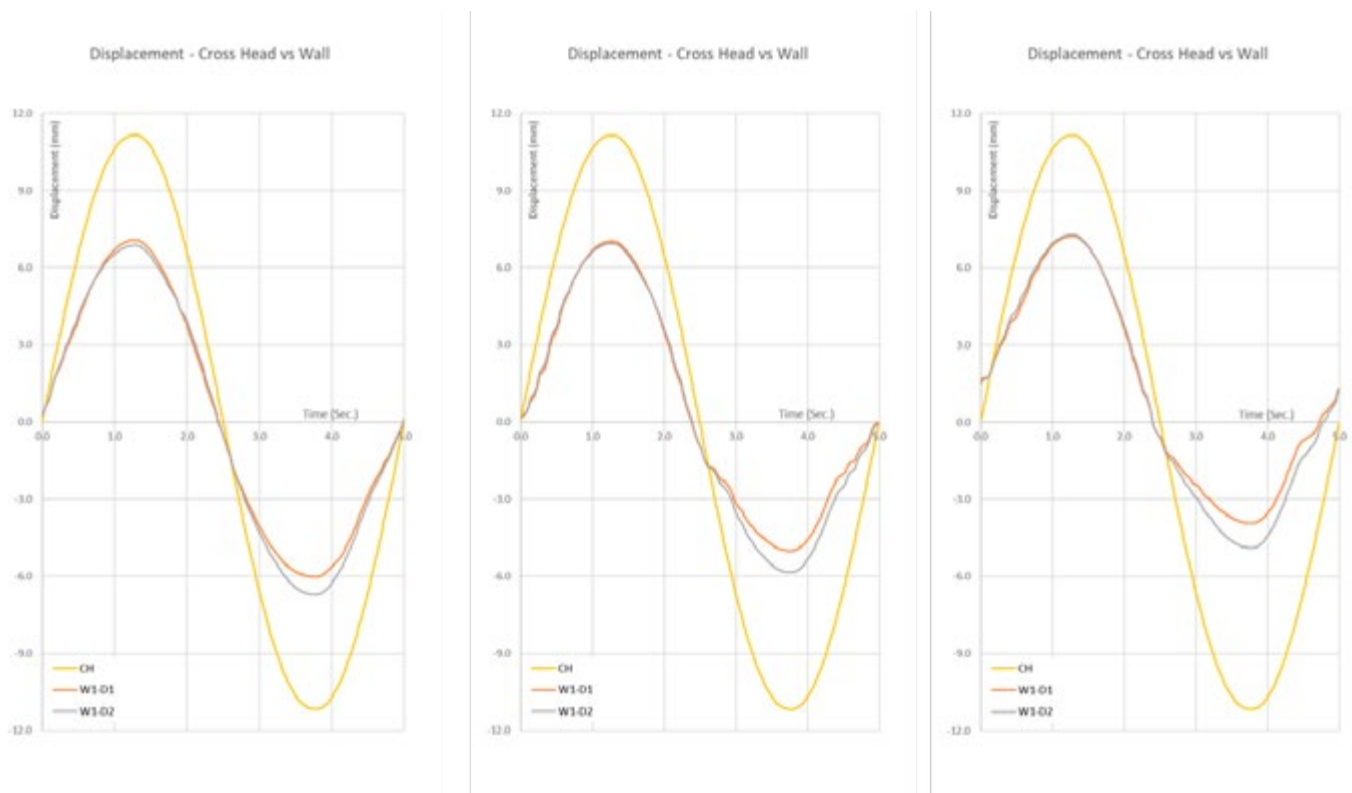
The graph on the previous page shows the comparative wall movement (orange and grey graphs) against the test rig (structure) movement (yellow graph), at an H/240 drift limit. The graphs, left to right respectively, depict (1) a conventional square set installation, (2) after removal of the screw fixing between the furring channel and perimeter channel and (3) after removal of the screw fixing between the furring channel and perimeter channel and screw fixing the perimeter channel to the plasterboard wall linings only.

It can be seen, when the test rig is moving in the positive direction, there is little change in the wall panel movement with approximately 7mm movement measured across all three wall panel tests. This is because the plasterboard ceiling is bearing against the end wall panel and pushing the wall panel, in addition to the racking force generated along the ceiling edge due to the perimeter channel and ceiling lining fixings into the wall panel.

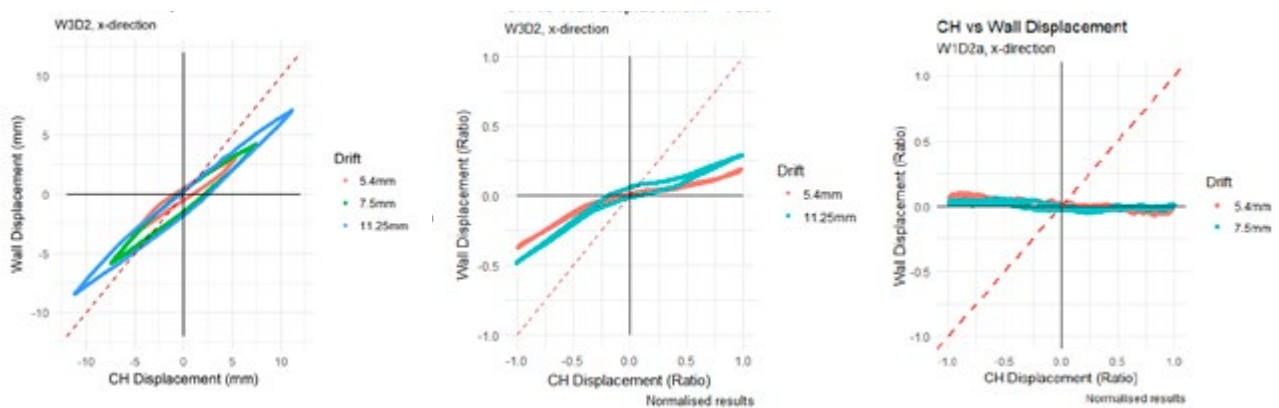
■ GRAPH OF WALL MOVEMENTS FOR ROUNDS 2, 3 AND 4 TESTING

These graphs show the wall movement relative to the testing rig. The red and green graphs are the wall movements at H/500 and H/360 drift lifts for Rounds 2, 3 and 4 of our testing programs. The graph has been normalised, and the axis may be taken as the percentage of relative movement of the wall panel.

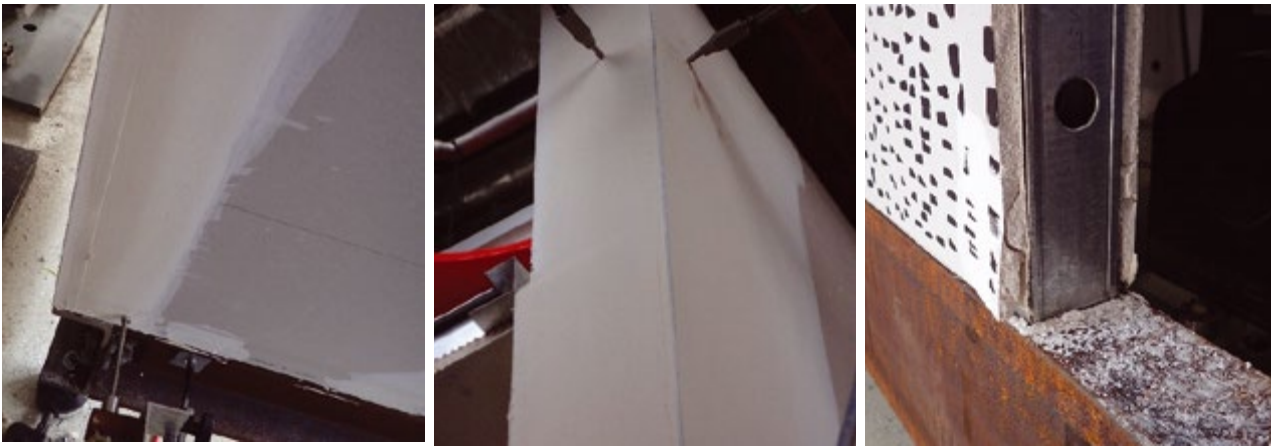
■ PHOTOS 3,4 & 5 – R2 L/360 (±5.40MM) EXTERNAL CORNER, NIB WALL END, DOOR OPENING BASE DAMAGE

There was visible damage to the wall systems after the completion of the four (4) L/360 drift tests, comprising X and Y directions in isolation and $X \pm Y$ in a clover leaf pattern. The no damage limit appears to lie somewhere between L/500 and L/360 drift for this type of construction.

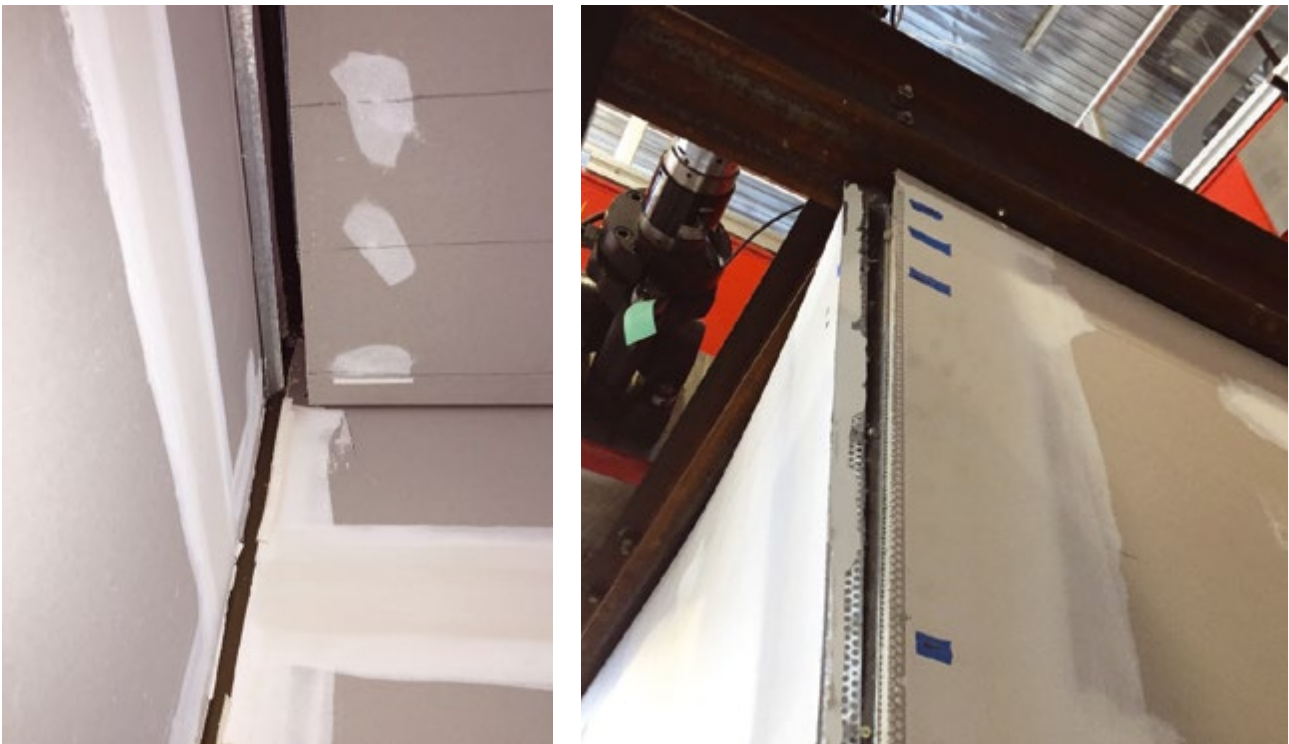
■ PHOTOS 6 & 7 – 1.5% DRIFT (40.5MM) INTERNAL CORNER, CEILING JUNCTION AND EXTERNAL CORNER

Between the L/360 (5.40mm) and 1.5% drift limits the damage to the wall and ceiling systems propagates and photos 6 and 7 show the extent of damage at the 1.5% drift limit. This level of damage and separation, whilst not resulting in loss of stability, would be quite disconcerting to any occupant of the building and would present significant issues for maintaining operational functionality for any services crossing these building elements.

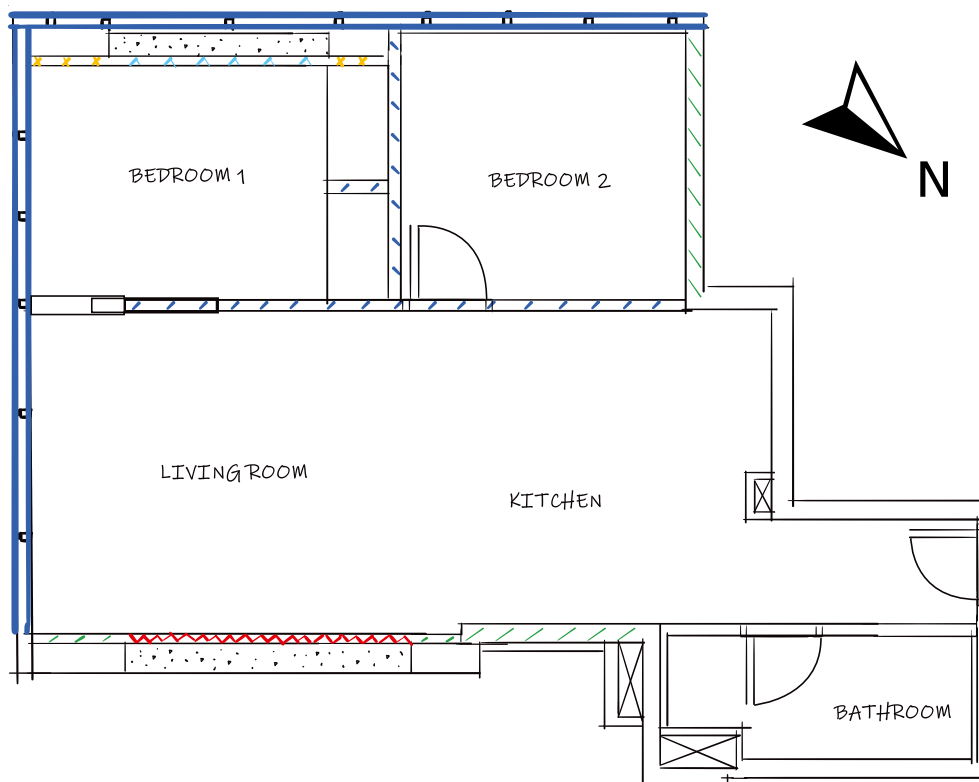
■ APARTMENT REBUILD FLOOR PLAN

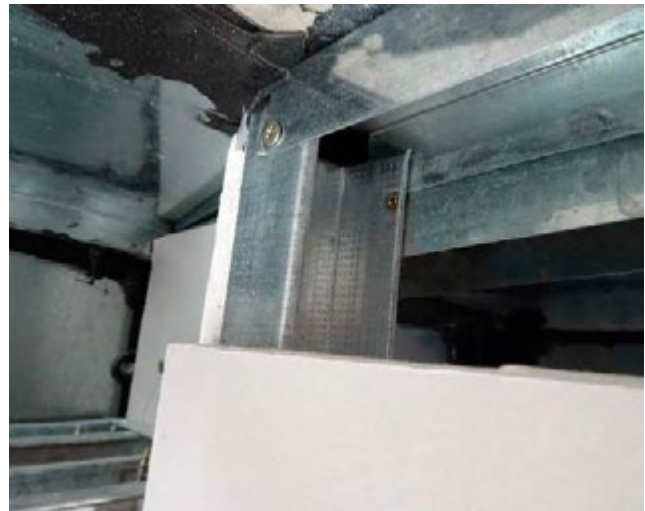
■ STEEL STUD FIXED INTO HEAD TRACK

1. Screw fixings installed into head track in some locations
2. Inadequate clearances between wall studs and services
3. Walls lined one side were not screw fixed into base track on the unlined side of wall
4. Nogging installation method not per Rondo recommendation
5. Temporary location screws in head track weren't removed prior to linings being installed
6. Header Track upturn too long and metal to metal contact with head track
7. Conventional Head Track (28mm flange) used in lieu of Deflection Head Track at column location
8. Insufficient stud engagement in Head Track
9. Wall studs cut without strengthening at cut location
10. Screw fixing into the bathroom jamb stud was removed and the stud moved such that the screw hole was no longer aligned, indicating the stud was under significant stress as a result
11. Linings screw fixed through glue daub locations

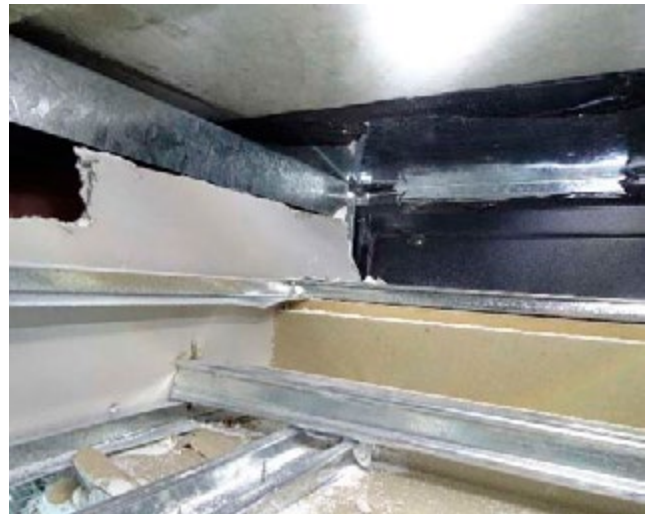
■ TCR SCREW FIXED TO PERIMETER CHANNEL AND CONTACT WITH LINING

12. Top Cross Rail screw fixed to perimeter channel
13. Inadequate clearances provided to services
14. Top Cross Rail and Furring Channels installed with inadequate clearances to abutting walls
15. Furring Channel Interchange Clips legs bent outwards at some locations
16. Suspension rods installed with large radius bends
17. Ceiling Suspension Hangers installed using power actuated fasteners, with concrete bursting evident at many fixing locations
18. Screws fixed through Furring Channel at suspension clip locations

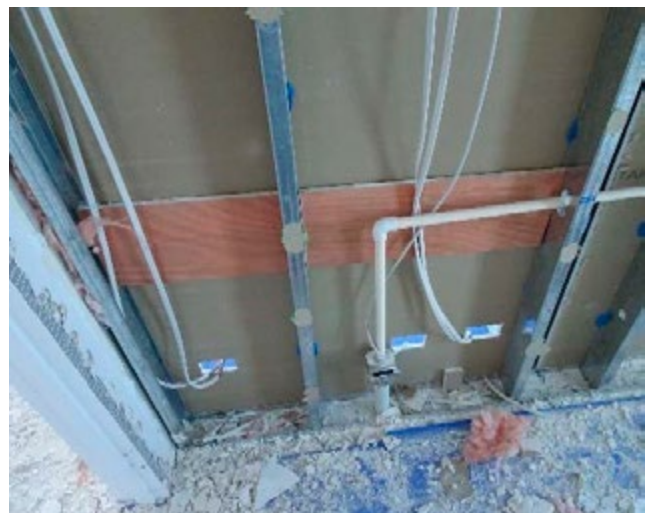
■ MISSING GROMMET AND PIPE SCRAPING ON STUD WEB CAUSING NOISE

19. Services installed with inadequate clearances to stud framing
20. Services installed with inadequate clearances to ceiling framing members
21. Installed services had insufficient space within the ceiling plenum in the bathroom and were bearing against the hallway wall
22. Drainage conduit for AC unit was installed without grommets or provision to separate the pipe from the wall stud and was rubbing on the cut service hole edge
23. Head Tracks cut unnecessarily for electrical cables. Where the internal non-rated wall linings are terminated below the head tracks the electrical services can be passed down the wall cavity without needing to cut the head tracks
24. Services penetrations through acoustic wall not provided with acoustic treatment
